Technical Service Bulletin 05T09  
5RP Rotary Union Drain

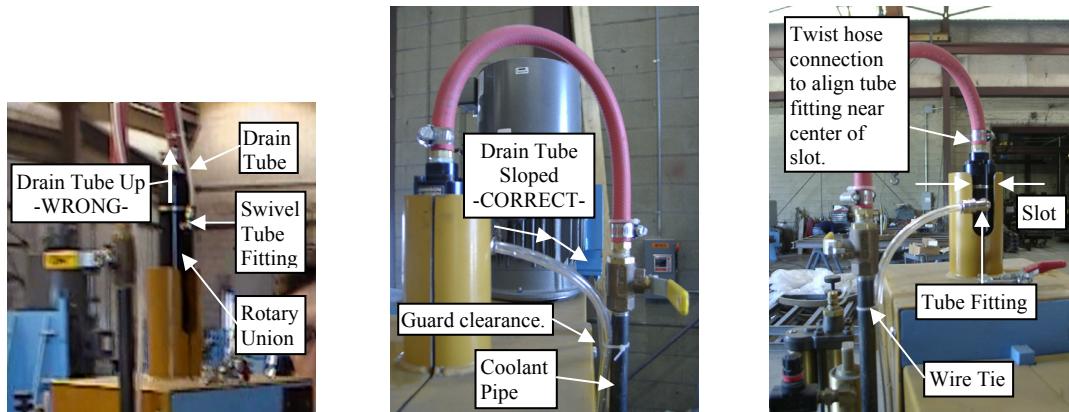
There is a drain on the side of the rotary union of your 5RP. (See the left hand picture below.) It is not installed correctly. The drain must be sloped to function as a gravity drain (See the center picture below) and the tubing size must be increased from  $\frac{1}{4}$ " OD to  $\frac{3}{8}$ " OD.

The union is capable of dry-running. When dry, its rotary seal faces are disengaged. Under normal flow conditions the rotary faces are engaged to prevent leakage. Under low-flow conditions the seal faces may be disengaged and leak and hence the need for the drain. Avoid the low flow condition that causes the seal to leak. Adjust the flow either off or high enough to prevent the leakage.

Snip the wire ties that secure the existing plastic tube. Remove the existing fitting from the union. Install a similar fitting sized for  $\frac{3}{8}$ " OD tubing. The SSI PN is HF-5000-468. The complete fitting description is Prestolok 1169-6-2S,  $\frac{1}{8}$ " NPT by  $\frac{3}{8}$ " OD tube 90° male swivel adapter. This type of fitting can be tightened in any position. The tubing should be  $\frac{3}{8}$ " OD x 24" long clear vinyl tubing (SSI PN: HF-5000-469).

To install the tubing, push it into the fitting about  $\frac{3}{4}$ ". (To remove the tubing depress the ring while pulling the tube.) The tubing end should be cut square and the outside should be smooth so it seats and seals properly. The tubing must slope down as shown and must not contact the edge of the guard or otherwise pull on the union. Use wire ties to secure the tube to the vertical coolant pipe. Do not overly tighten the ties or pinch the tubing. Route the tube down the pipe and angle the discharge toward the back. The fitting should be centered in the slot in the guard. To accomplish this it might be necessary to loosen the red hose and twist it about the barbed fitting in the top of the union. Raise and lower the spindle to confirm all is well.

There are a total of 4 drain ports around the union. One port must drain and the other 3 must remain plugged. Failure to implement this change will void the warranty on the union.
