Technical Service Bulletin 05T12

5RP Top Bearing Cap

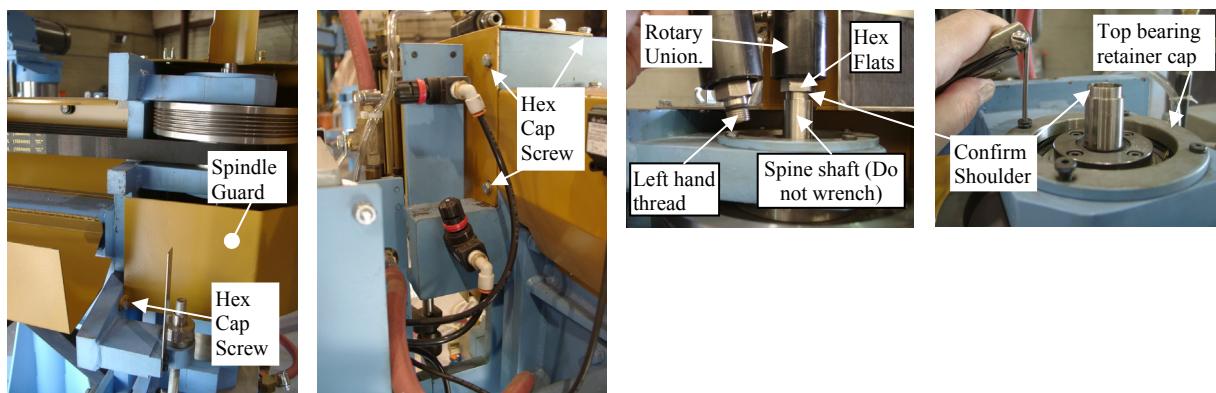
Before beginning work, confirm that your spline shaft has a shoulder for installation of the Slinger Ring. (See two pictures of the union and spline shaft below right.) If not, SSI will need to send a different style slinger ring to fit over the union. The entire job should take about 1 hour and minimum mechanical skill.

Remove rotary union from spline shaft. This is a left hand thread. Apply wrench to the hex flats below the union. Restraine the shaft from turning by holding a wrench to the wrench flats on the end of the spindle shaft. Do not apply a wrench to the spline shaft below the union.

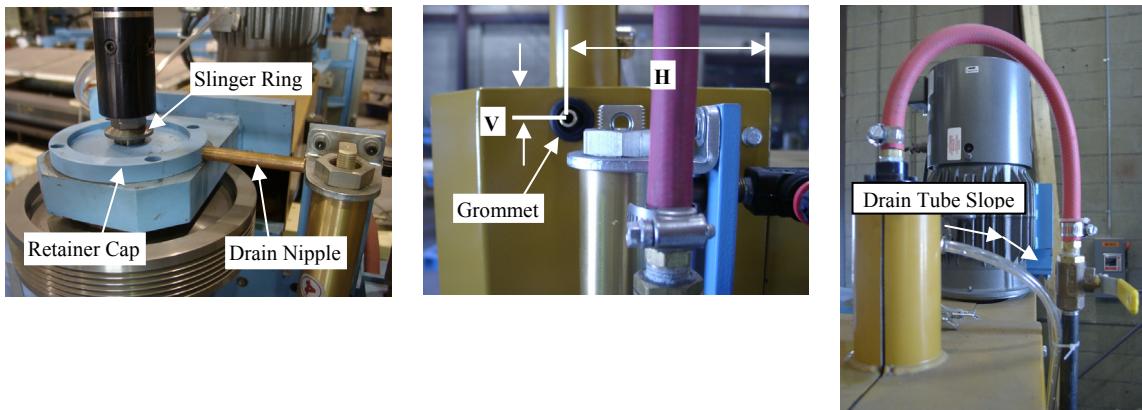
Screw the pipe nipple into the drain hole. Use a straight edge and square to confirm the center of the nipple is located 5-3/16" from the back edge of the back plate (dimension "H") and 11/16" from the top edge of the back plate (3/4" from the top edge of the guard (dimension "V").

Mark the proper center location on the spindle guard for a clearance hole for the nipple. Punch or drill a 1-1/16" hole in the guard for the grommet. Punch this hole undersized if possible. Put the guard and nipple temporarily in place to confirm the hole is centered. Make any adjustment to the hole location and then enlarge the hole in the proper location.
